# Historic Renovation at Pitzer College

Building Type & Use: Multi-use Classroom Building

Location: Claremont, CA

Highlights: ILFI-certified/LEED-Platinum, zero carbon design, building envelope retrofit, daylighting, natural ventilation

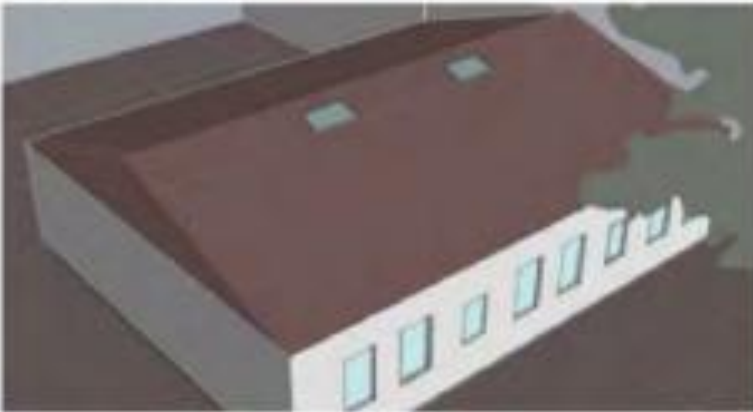
Option 2

Two skylights separated for more even light distribution in the room

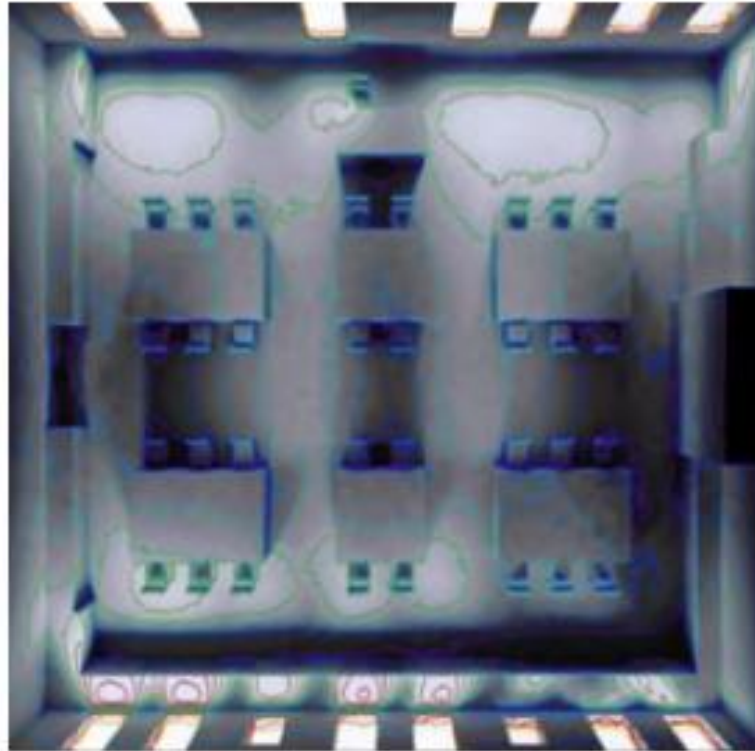
Dec. 21, 12 noon, Overcast Sky

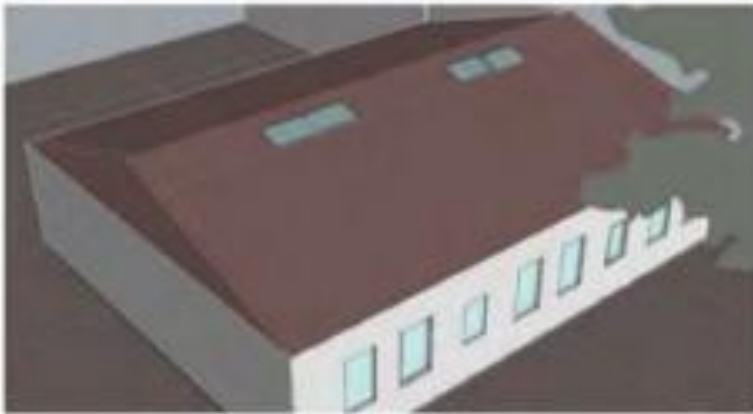
Option 3

Two pairs separated for higher daylight levels overall

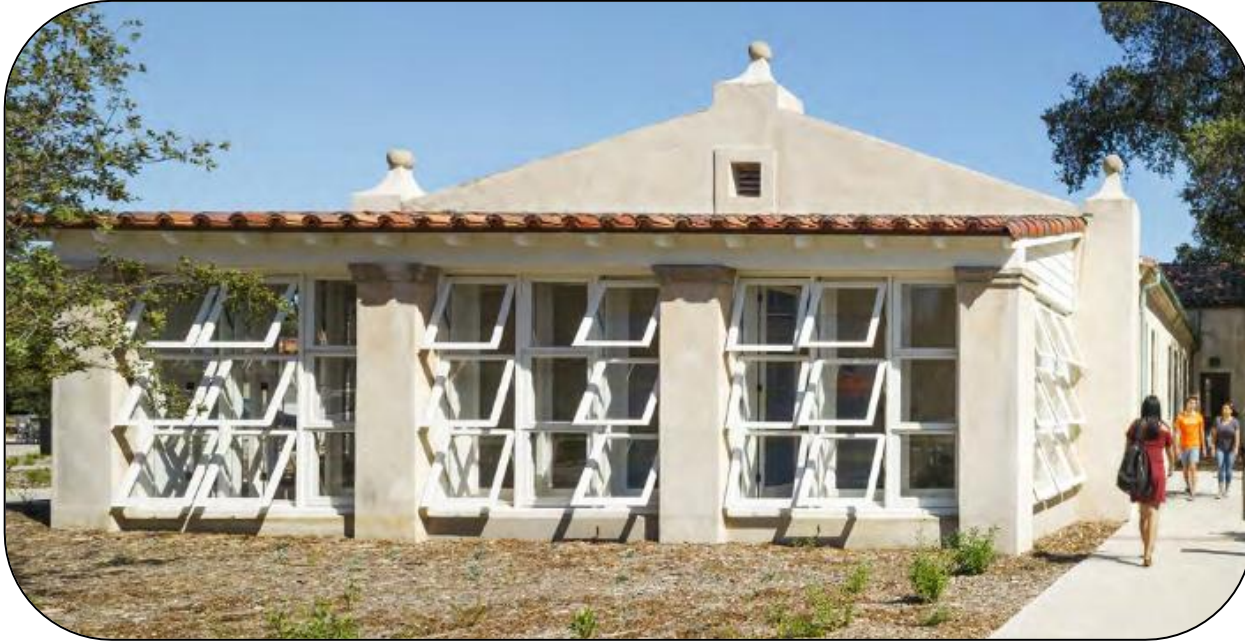
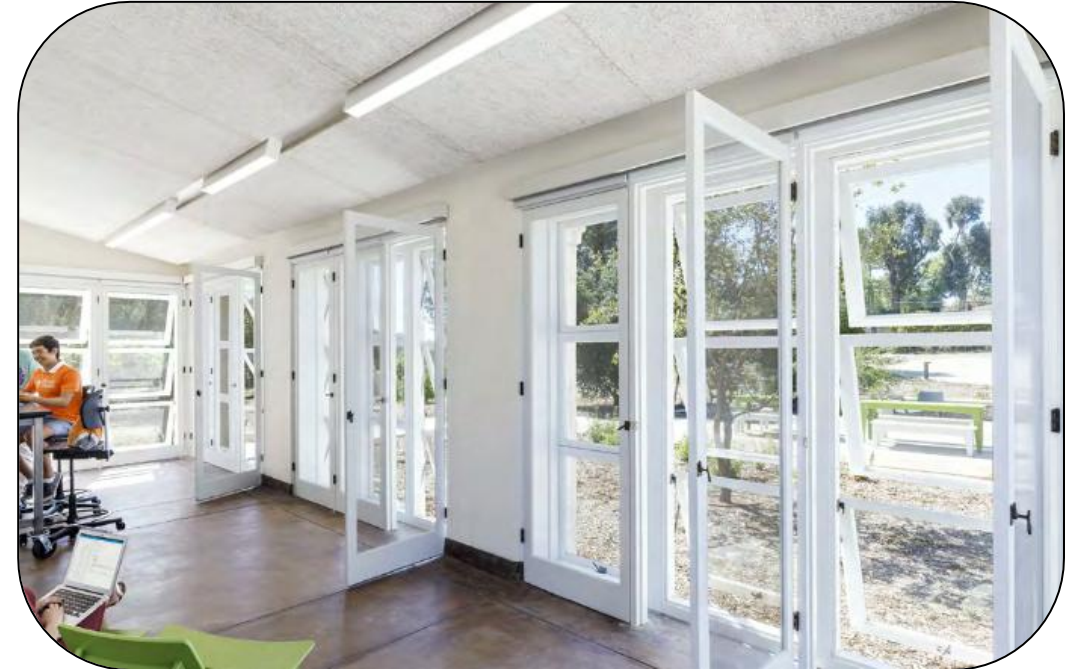
# Natural Ventilation

The seasonal air temperature ranges at the site are ideal for natural ventilation for fresh air and cooling: cool night temperatures for space pre-cooling and daytime air temperatures within the comfort range most of the year. The designers used the existing crawl space beneath the wood joist floors combined with the operable skylights to create an air flow path through the main spaces, with the air intake at openings in the exterior wall of the crawl space and a connection to the occupied space above through floor grilles.

This effect is enhanced by broken shards of the red hollow clay bricks that line the crawl space, which were placed there after the original interior walls were demolished and the bricks were broken into pieces. This effectively adds thermal mass to the crawl space, which is used to pre-cool the incoming outside air. This thermal mass is typically chilled during night purge ventilation of the building.

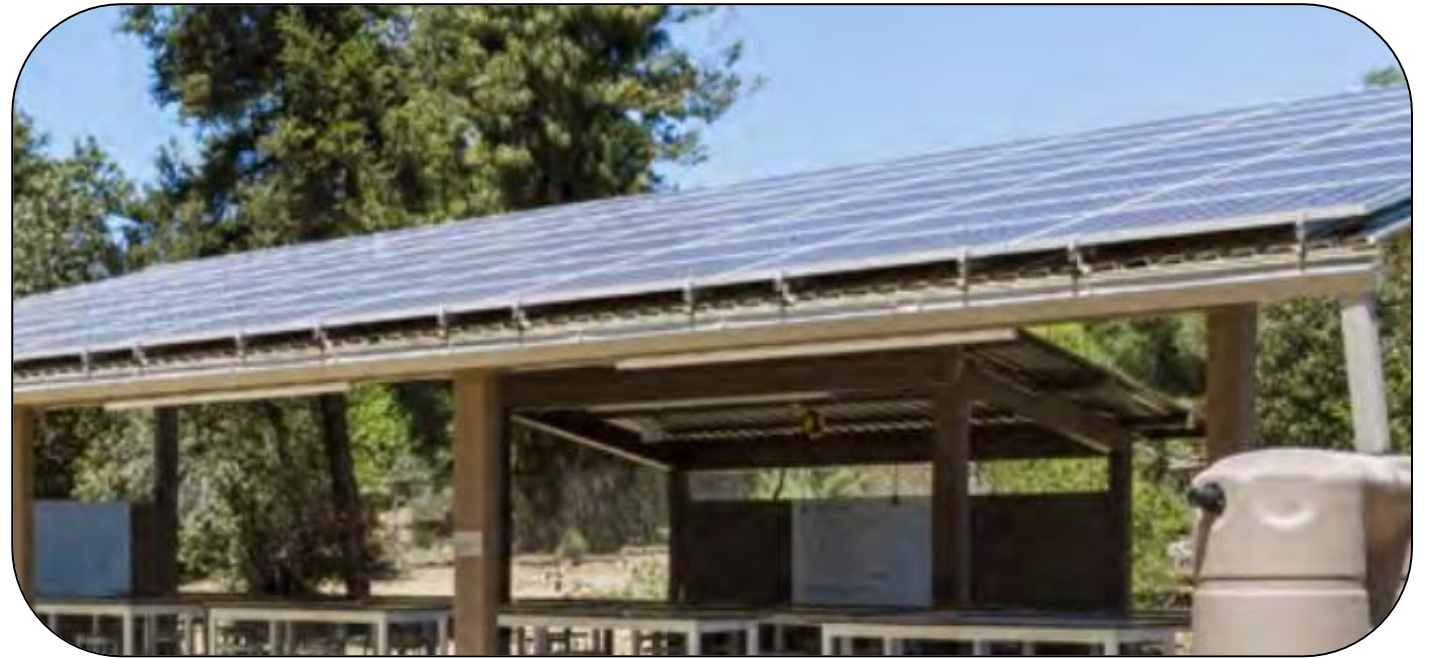
The solar PV system was installed on the two roof canopies above the outdoor classrooms, which together provided sufficient area to accommodate the required panel arrays. The system comprises 160 SunPower E-Series Commercial Solar Panels (E20-327-COM), with a nominal capacity of 52 kW
